NAWS China Lake Earthquake Response and Recovery

SAME San Diego Post Luncheon
September 11, 2019

ReidMiddleton

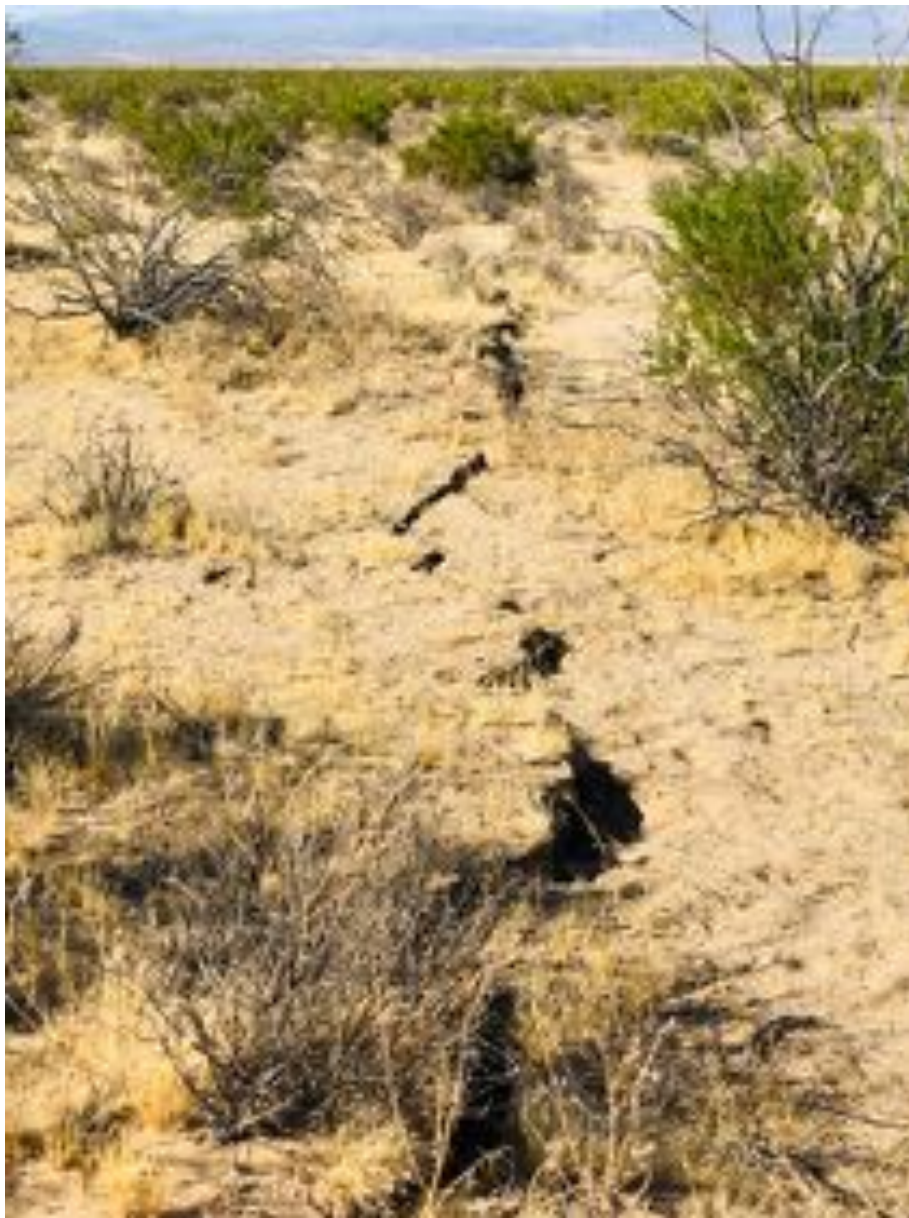
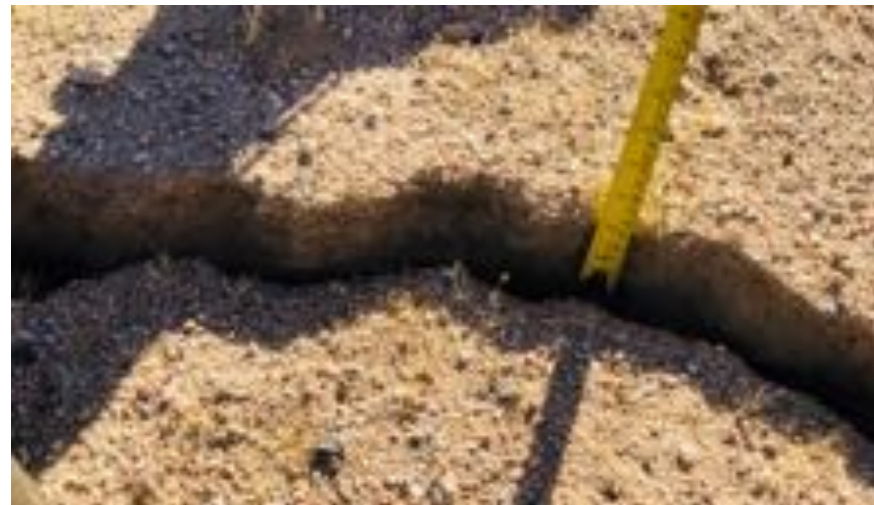
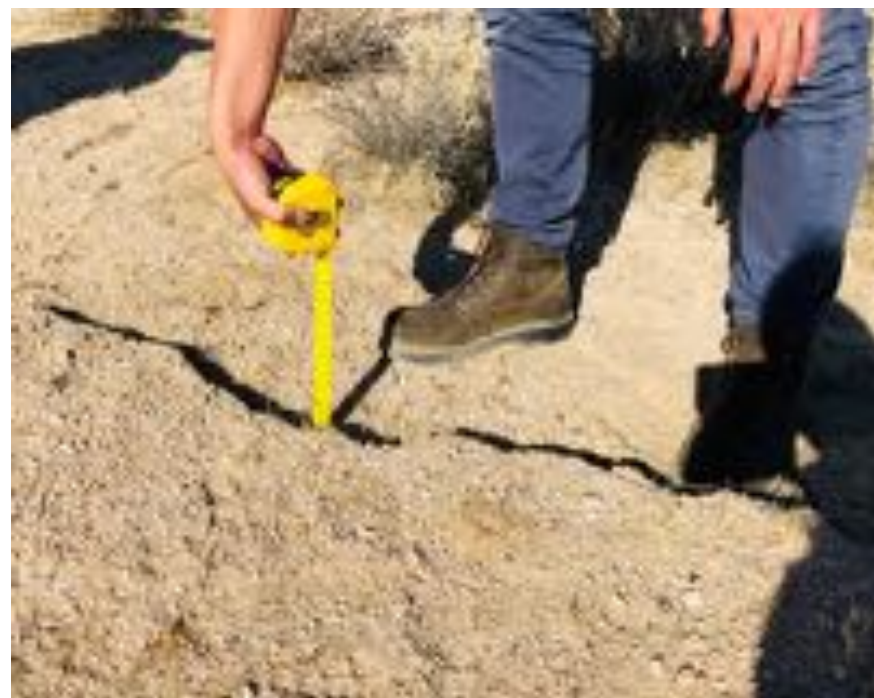
Surface Faulting

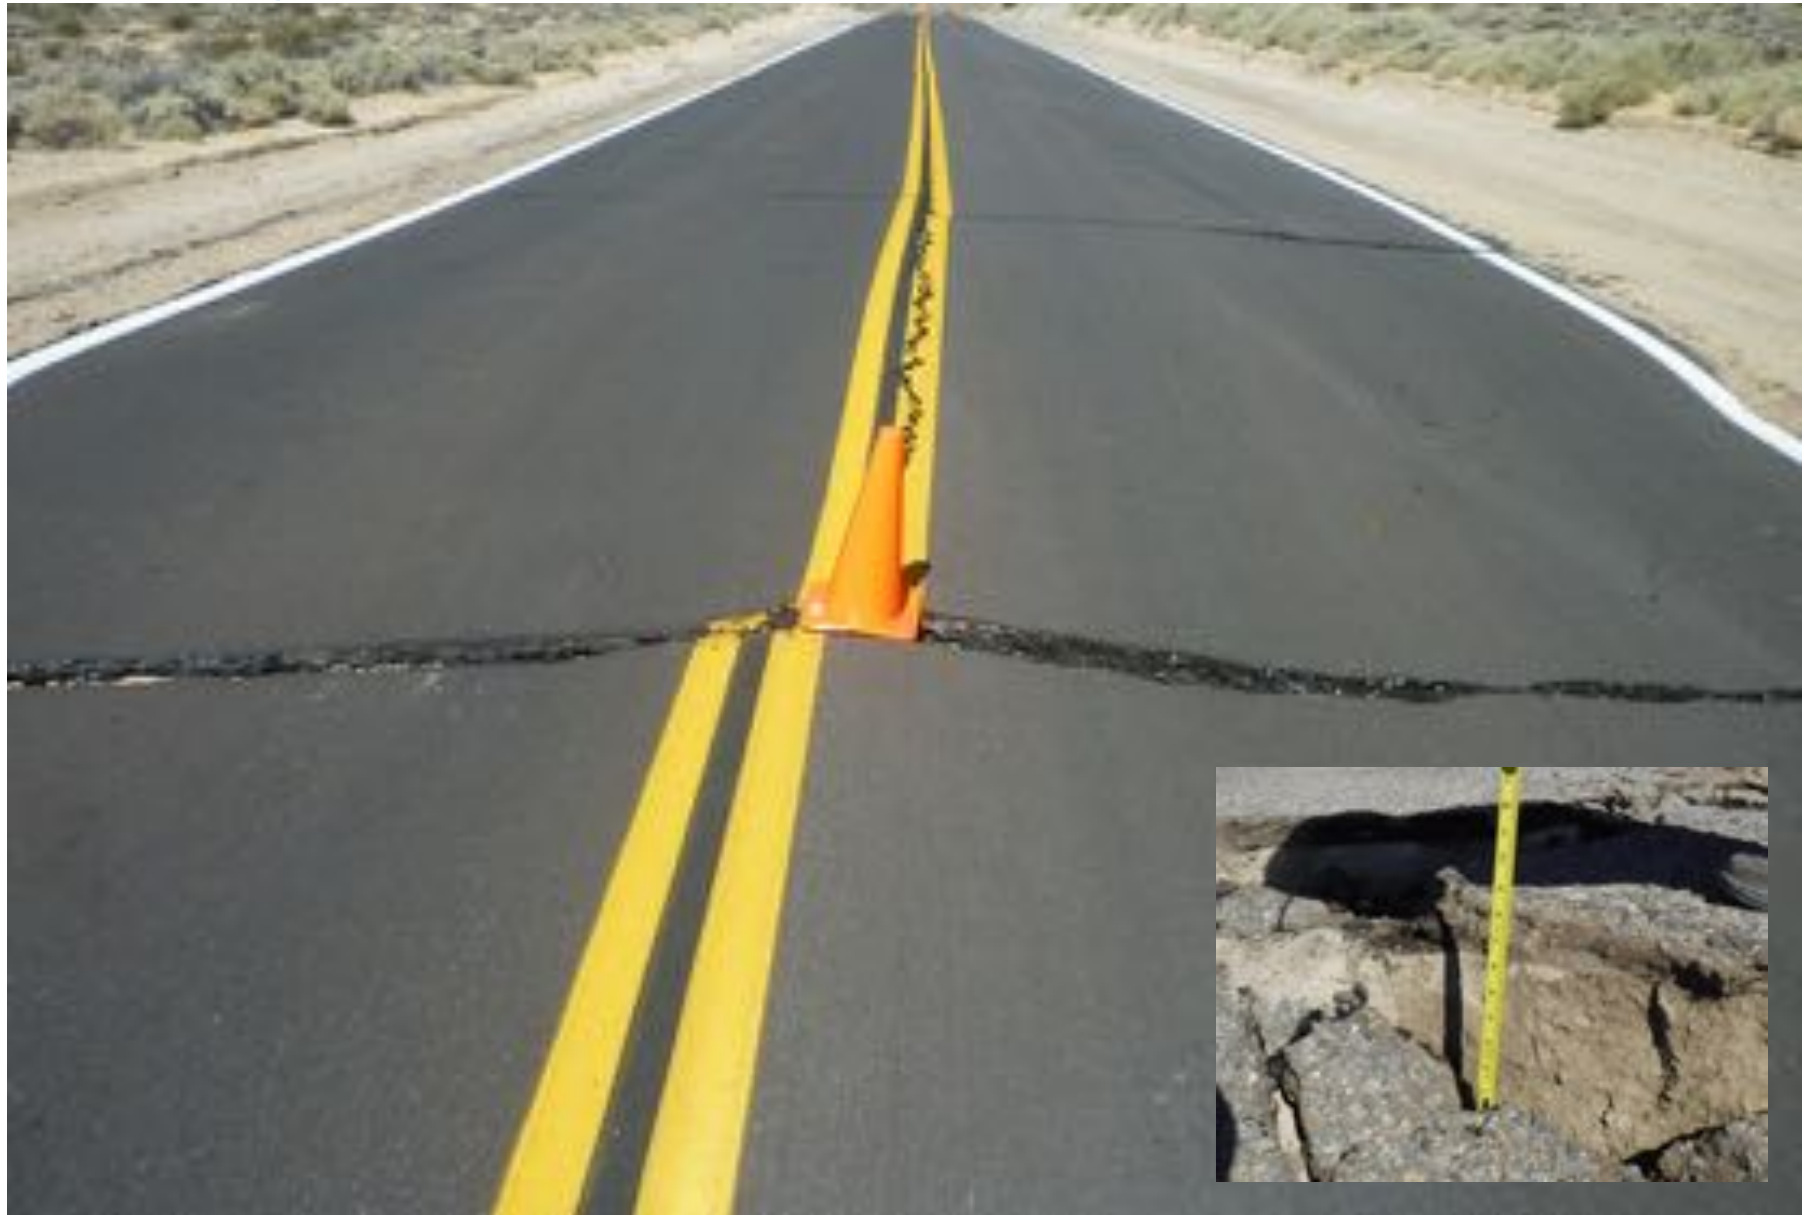
Roadways

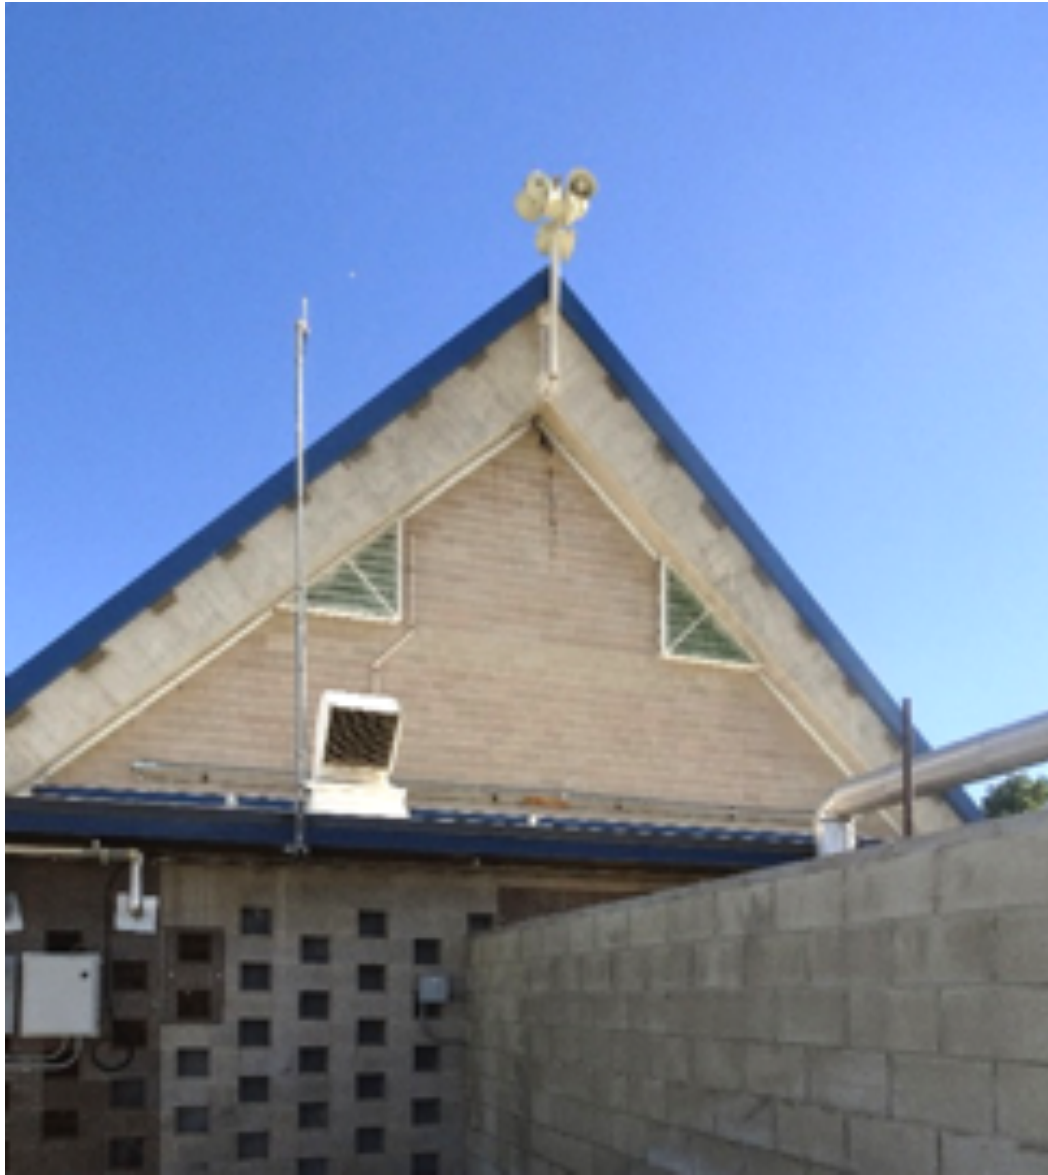
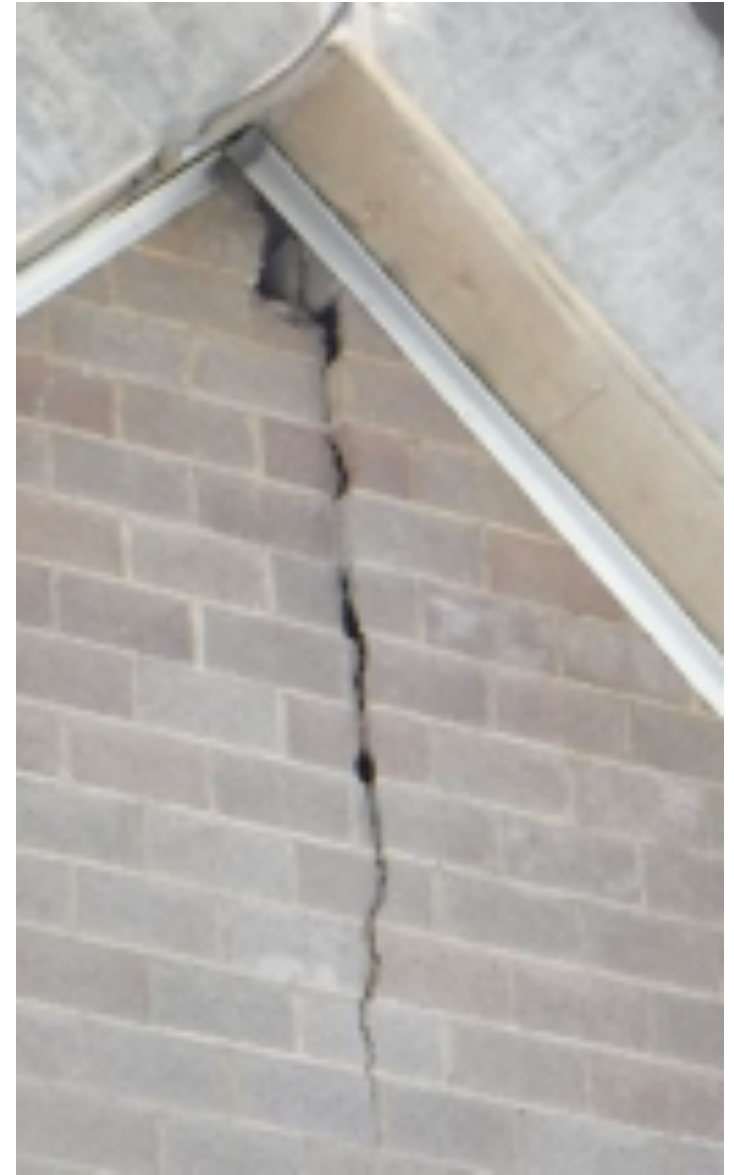
Concrete and Masonry Building

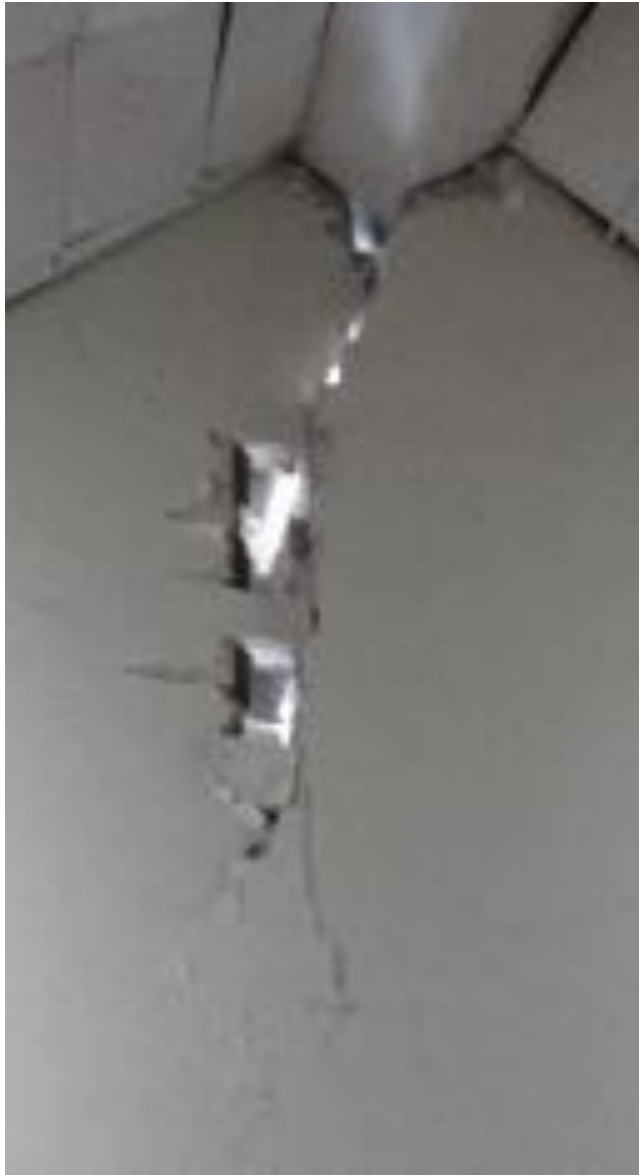
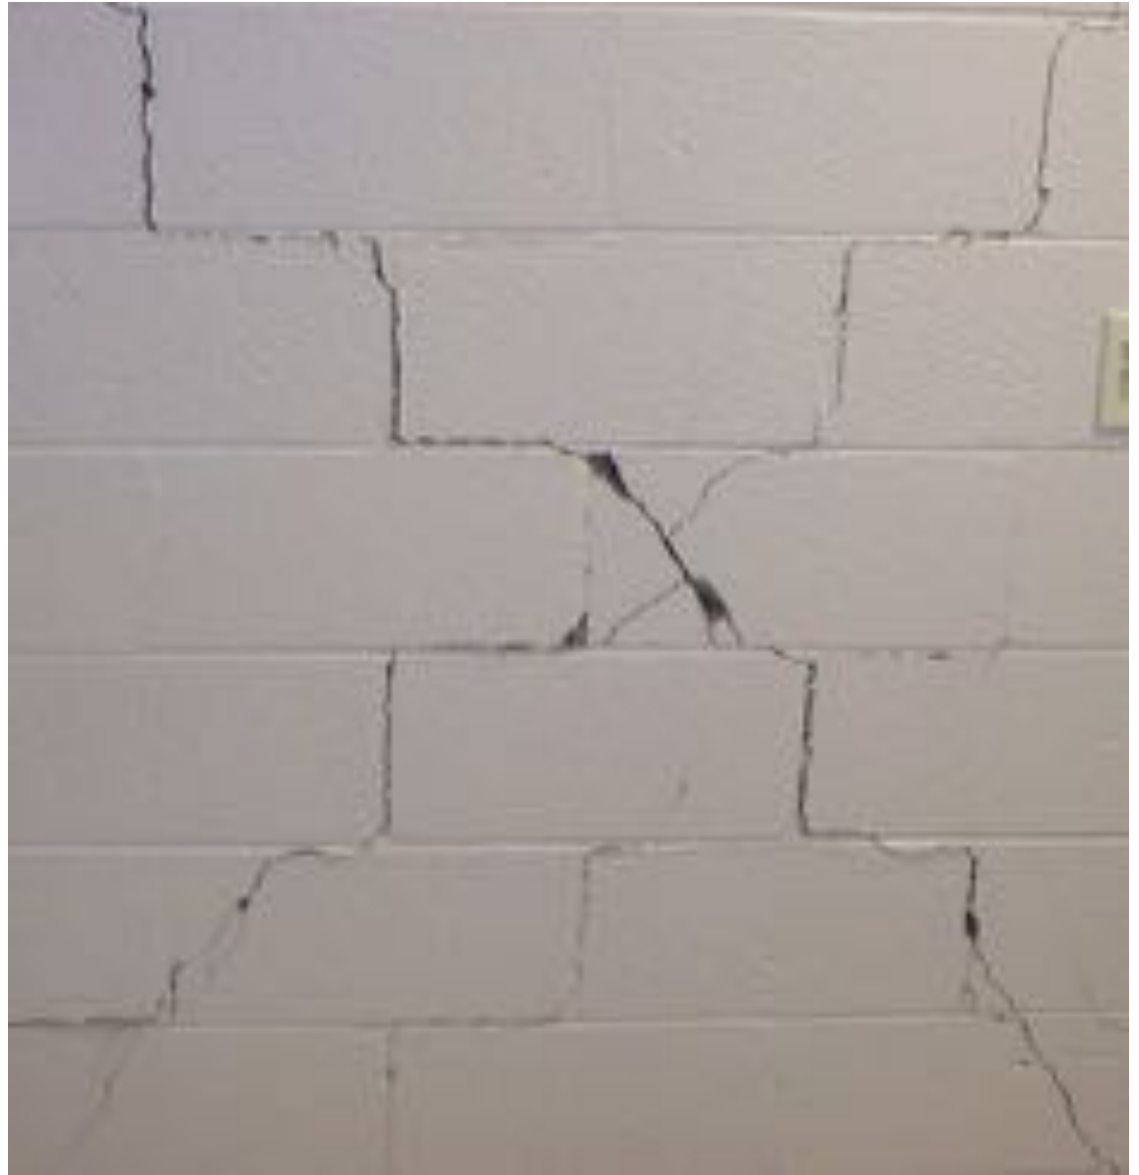
Concrete and Masonry Building

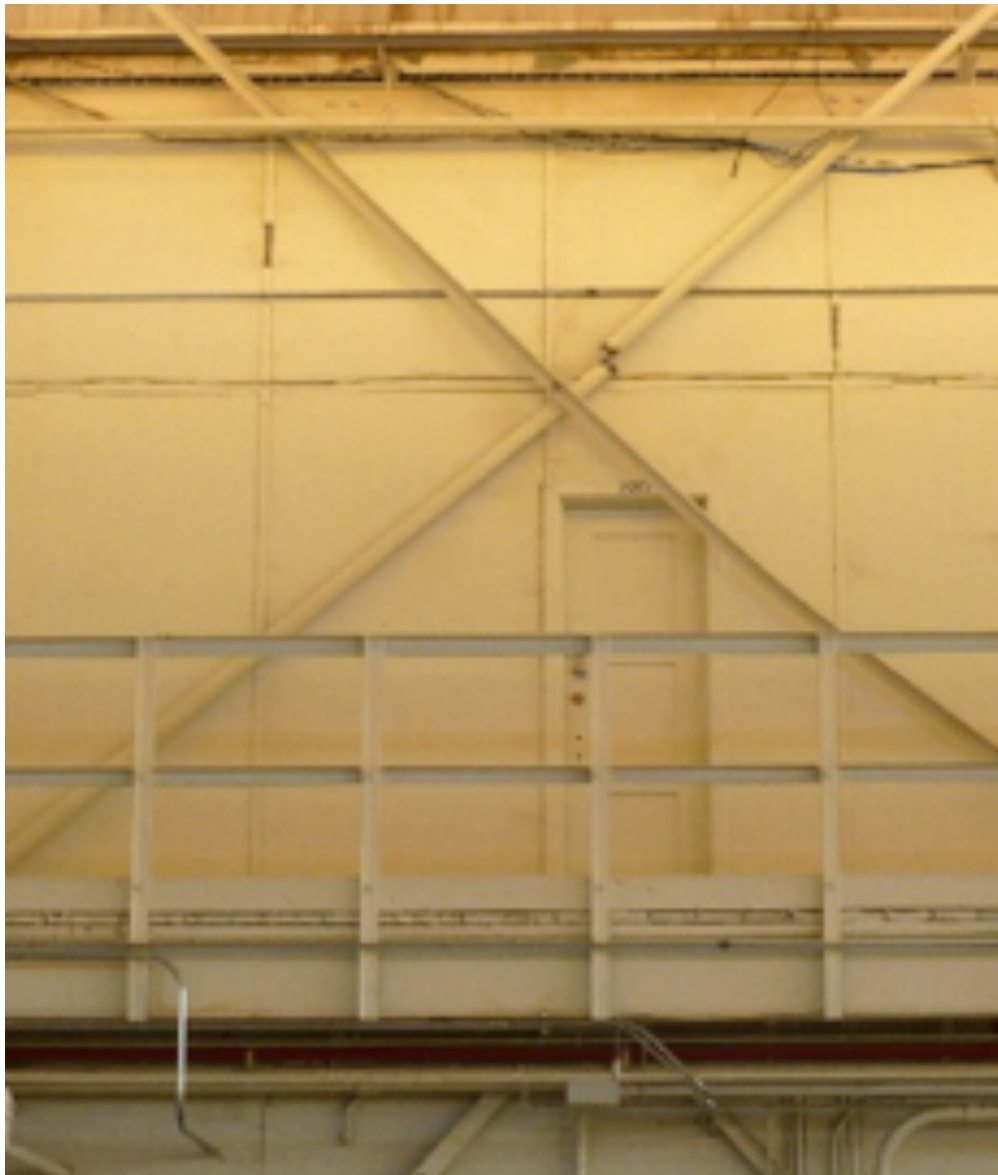
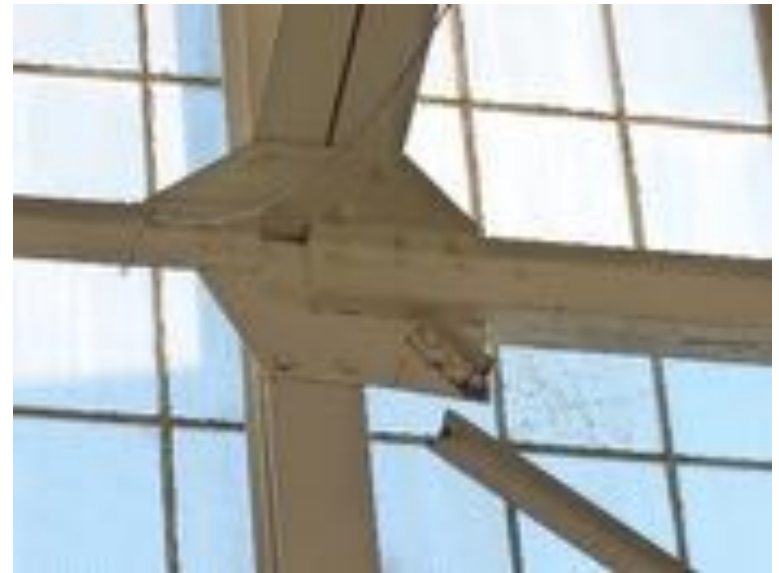
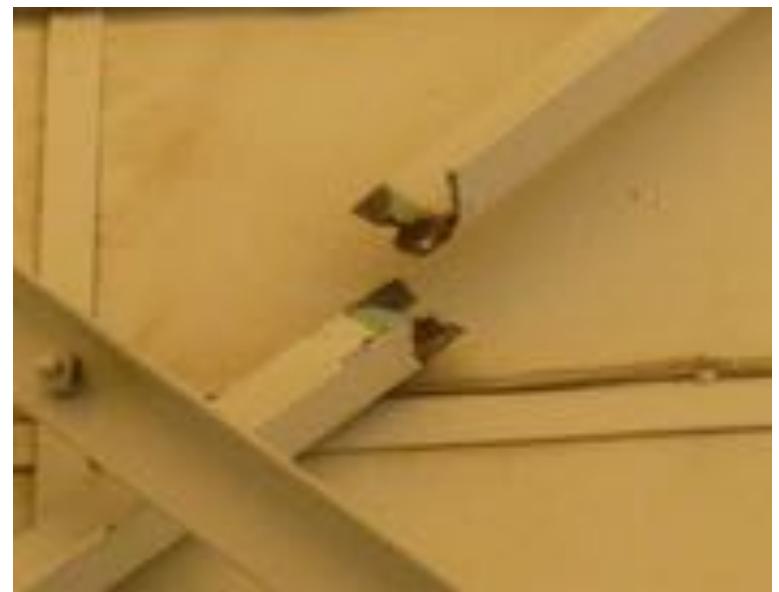
Steel Braced Frame Hangar

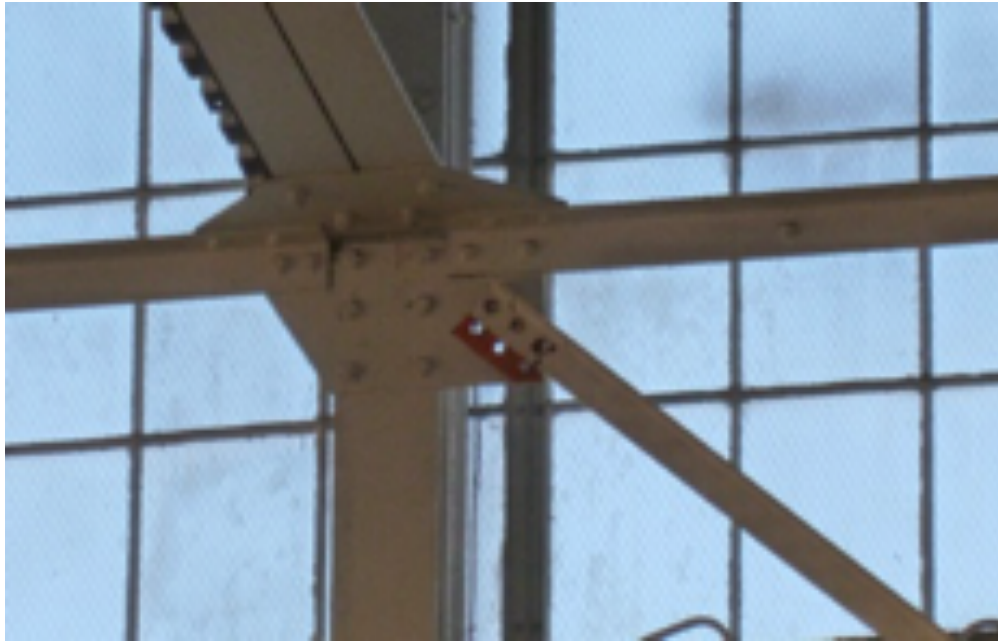
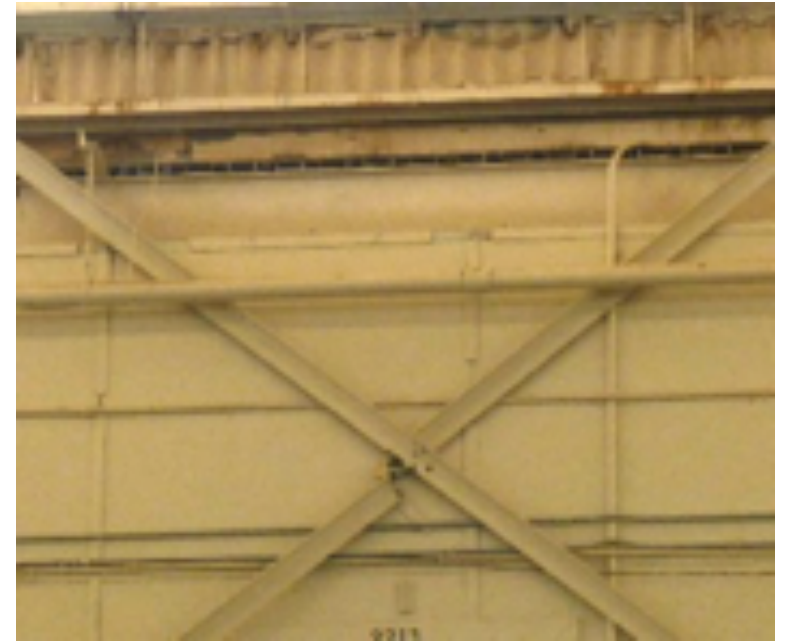
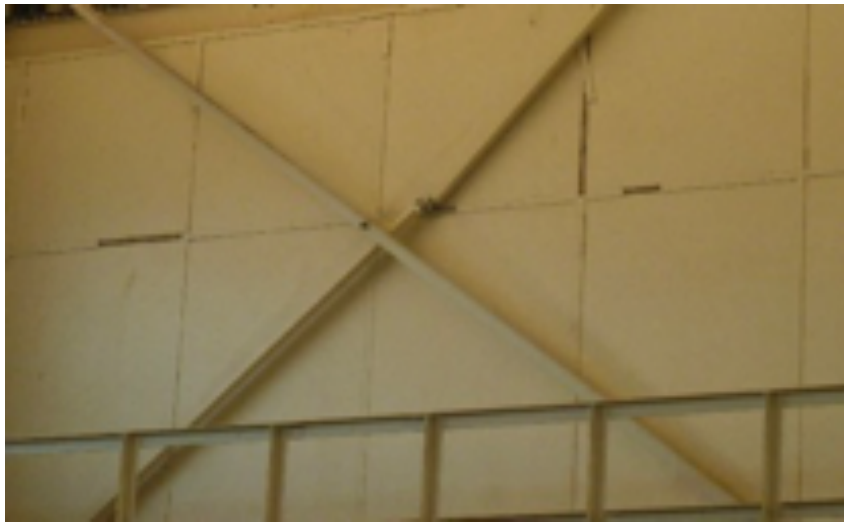
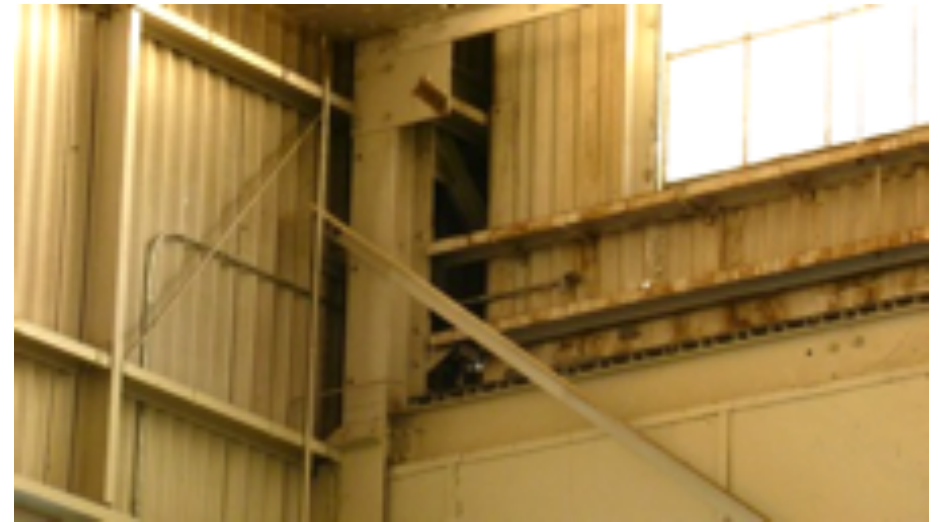
Steel Braced Frame Hangar

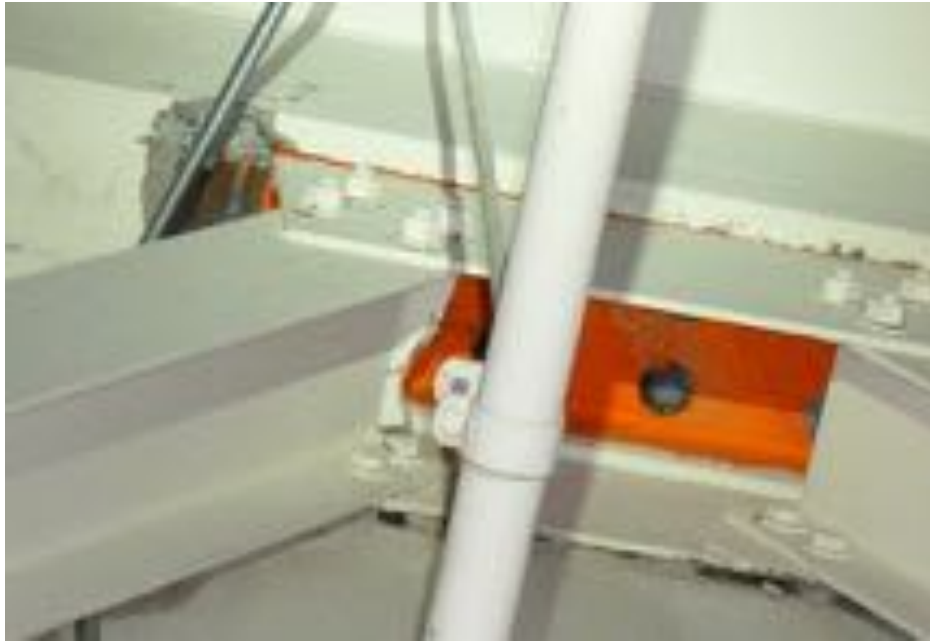
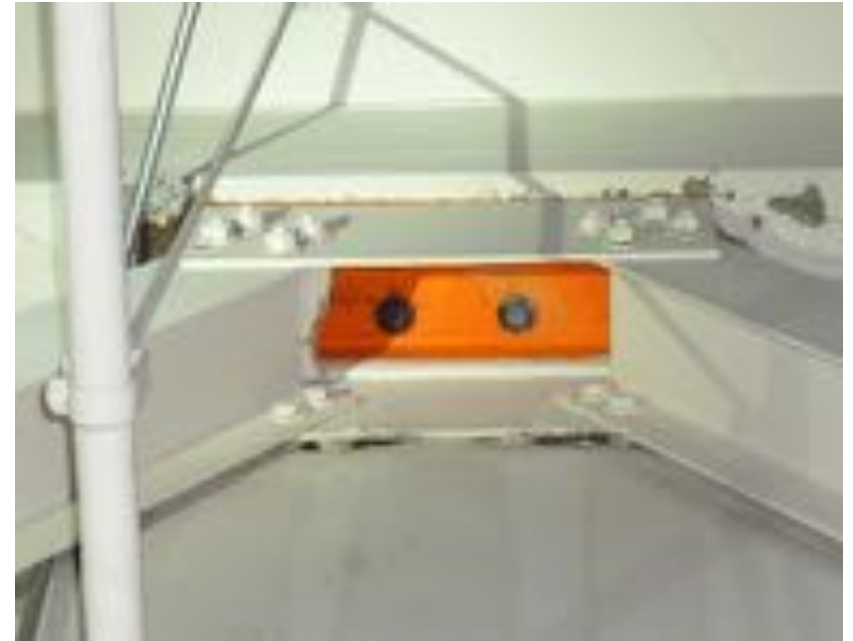
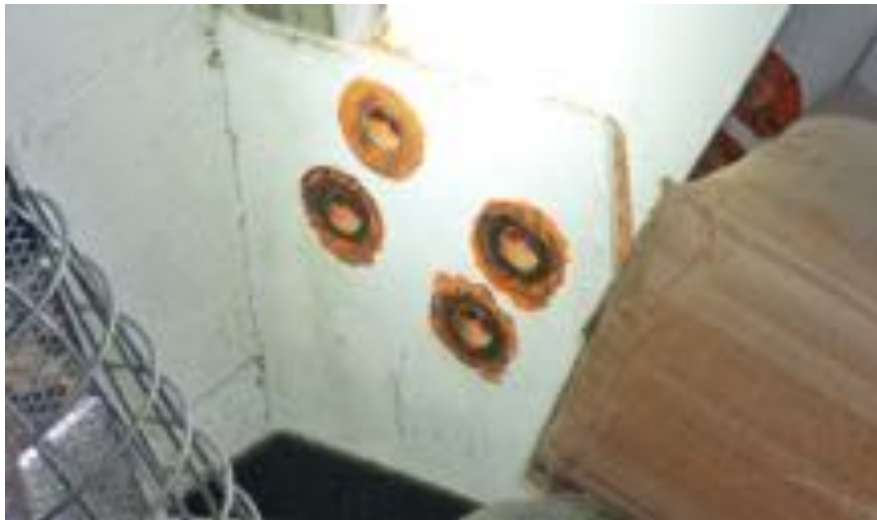
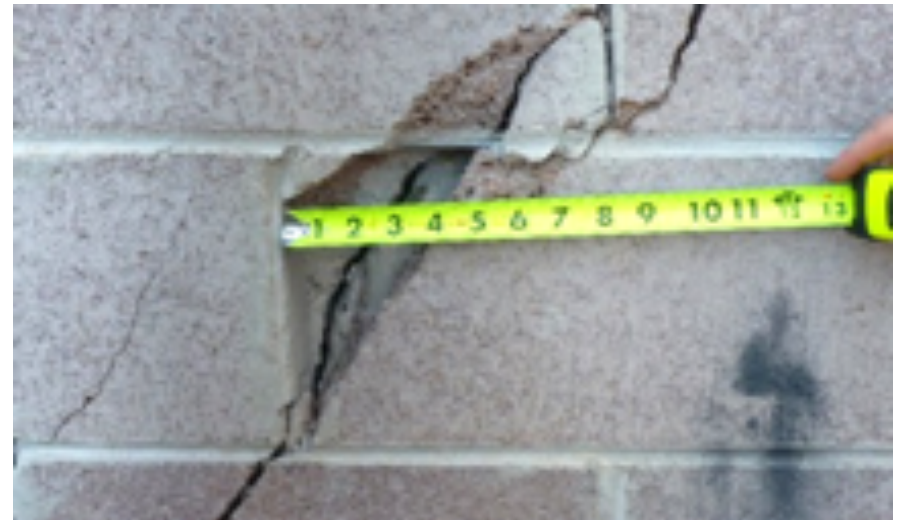
Steel Braced Frame Hangar

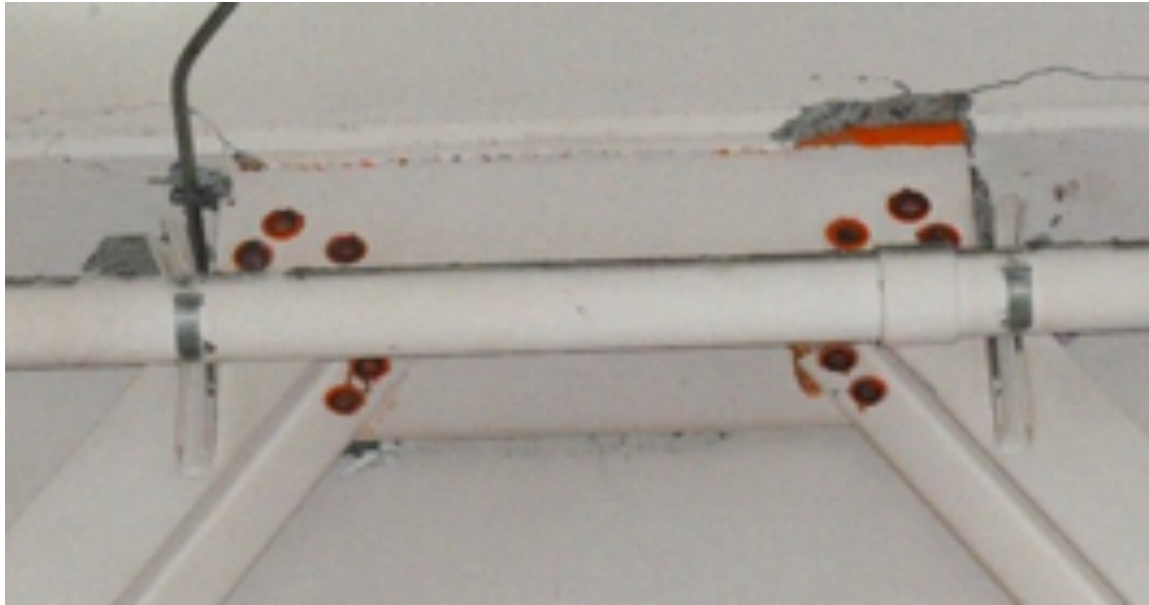
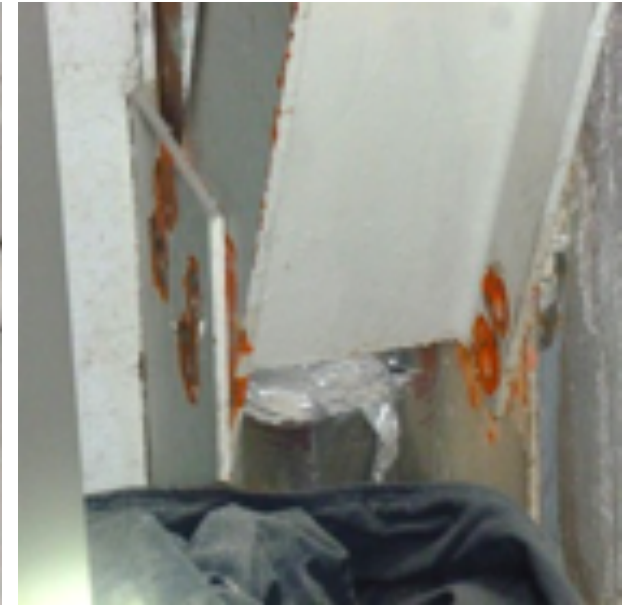
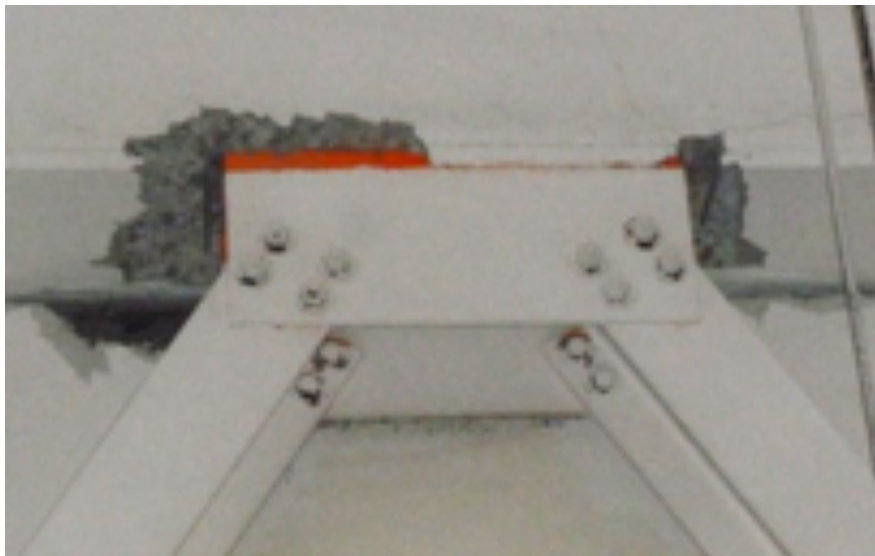
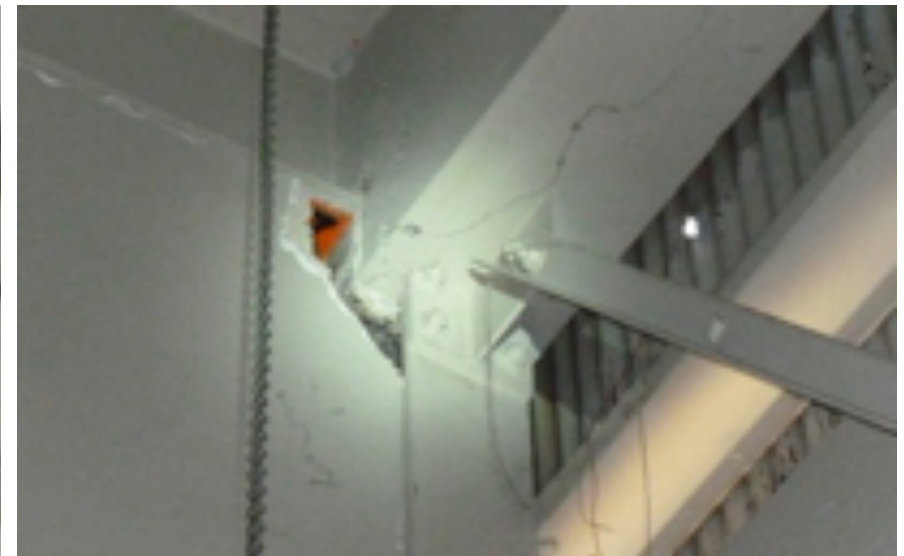
Steel Braced Frame Hangar

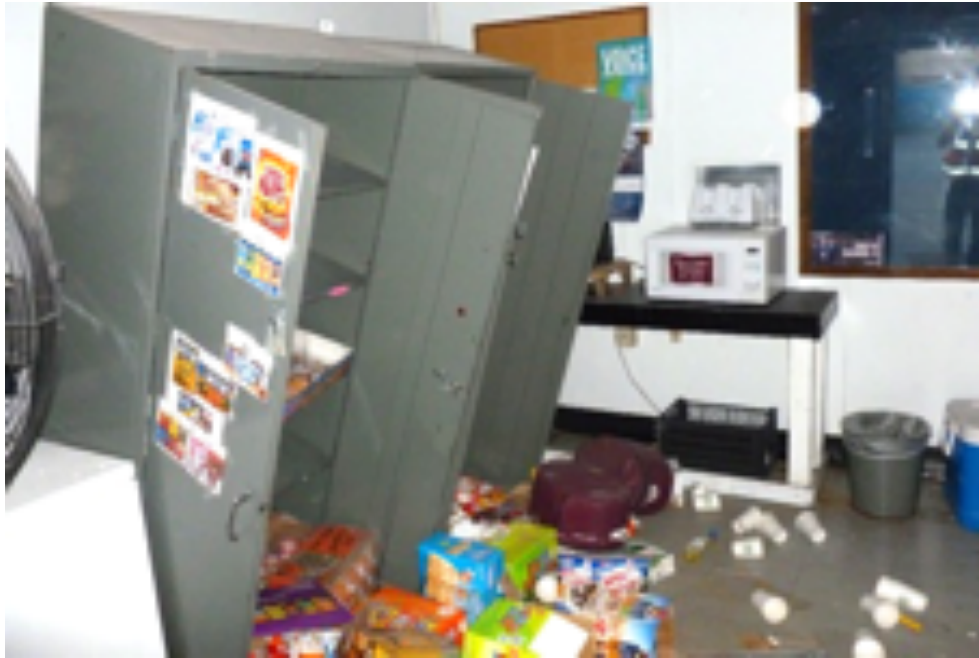
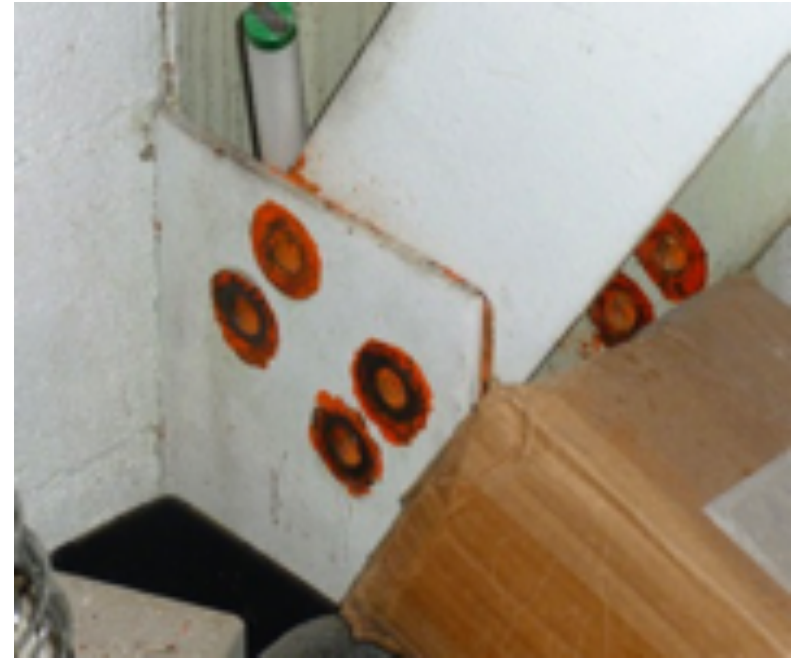
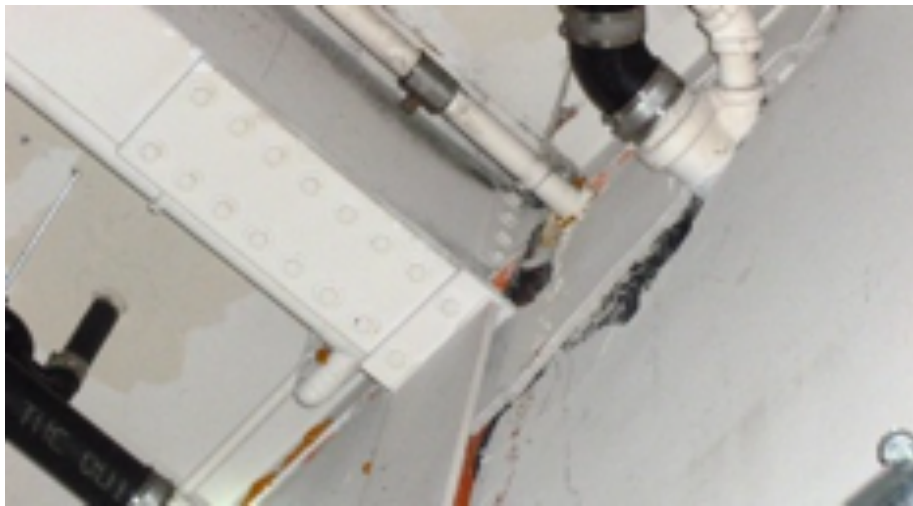
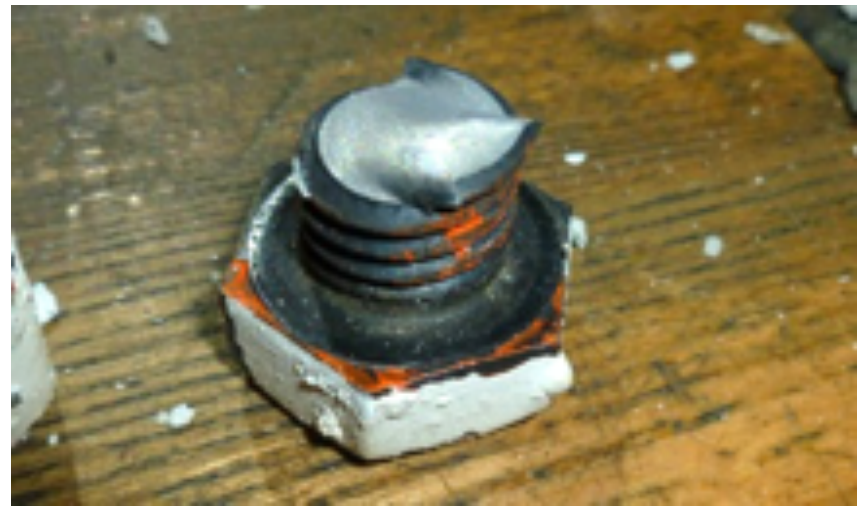
Steel Braced Frame Hangar

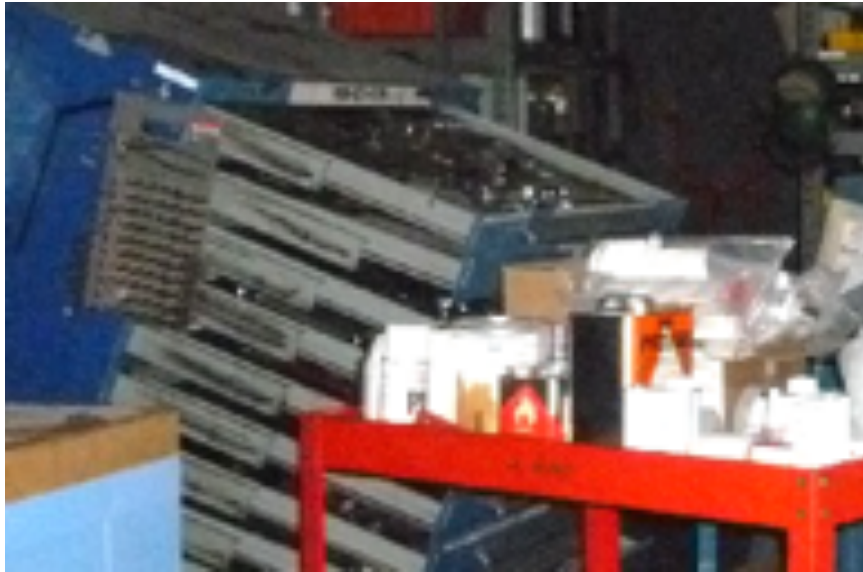
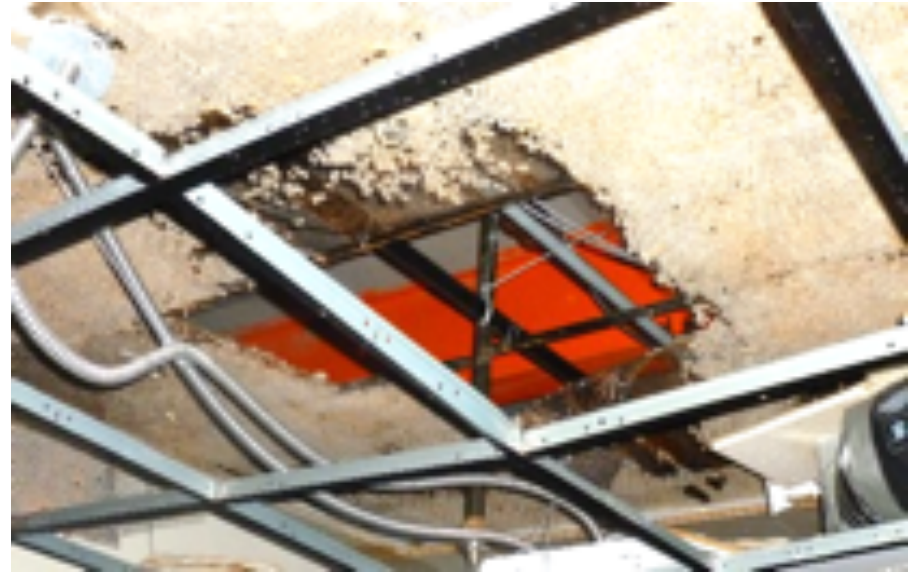
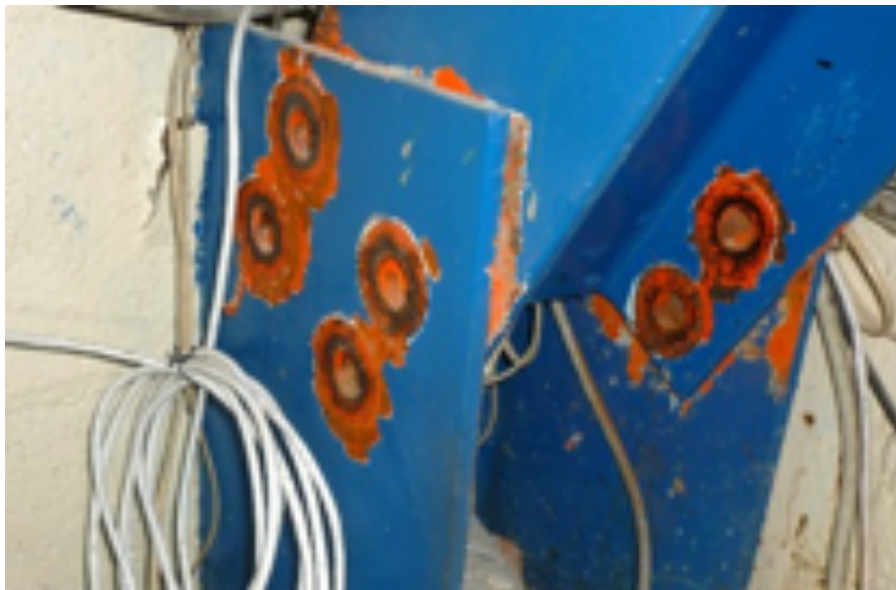
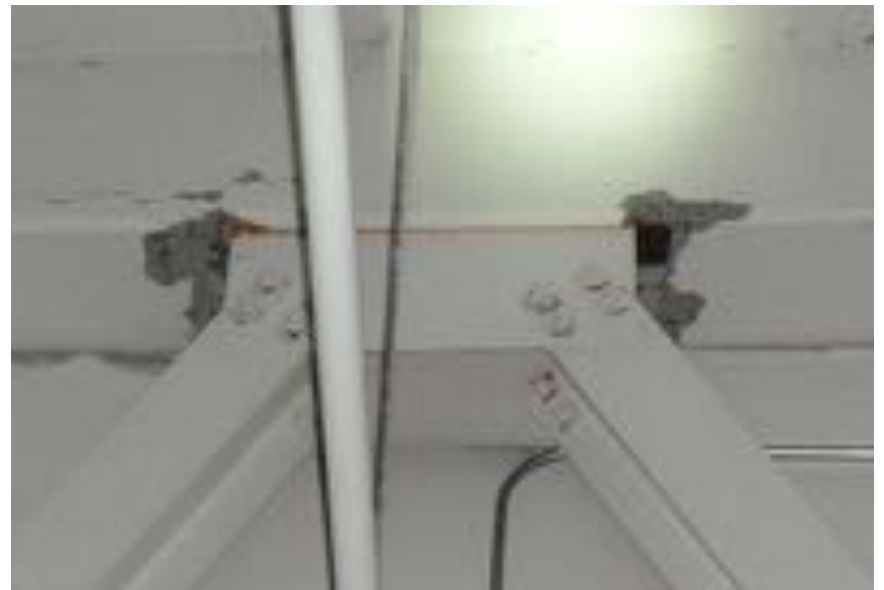
Steel Braced Frame Hangar

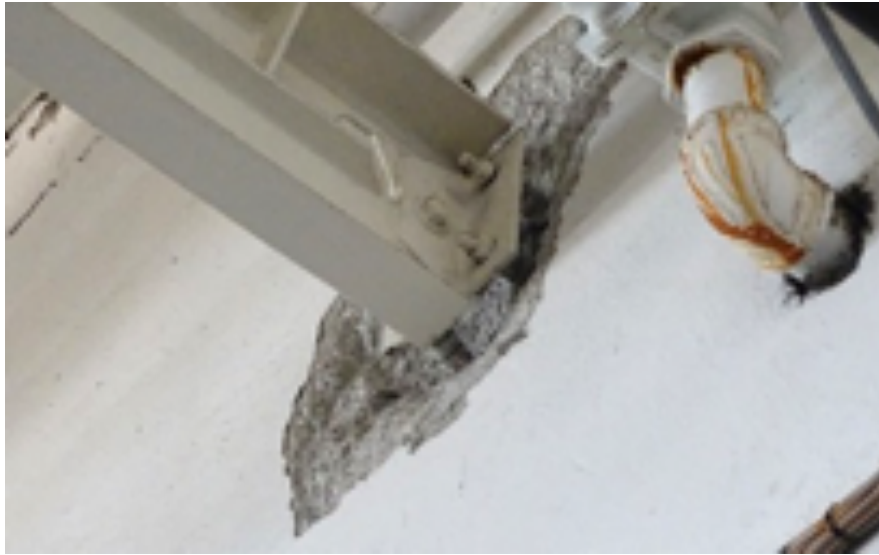
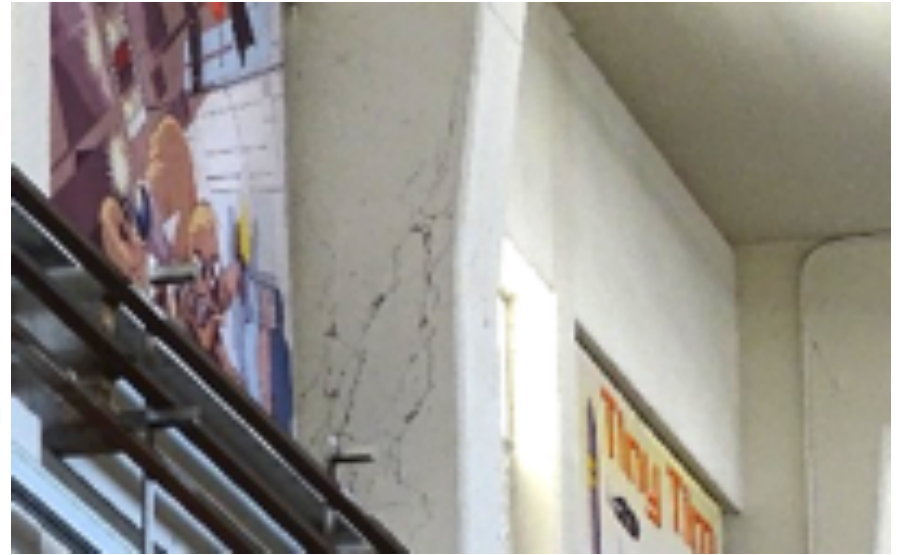
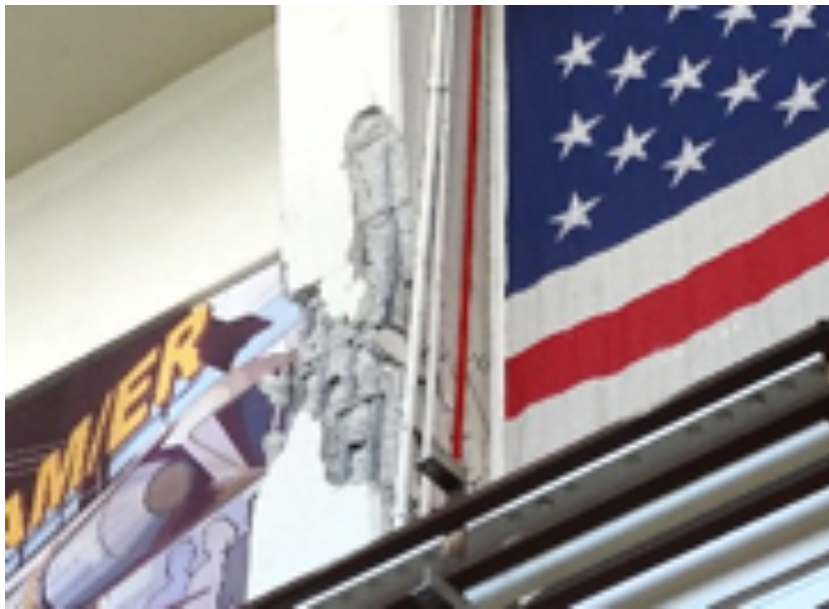
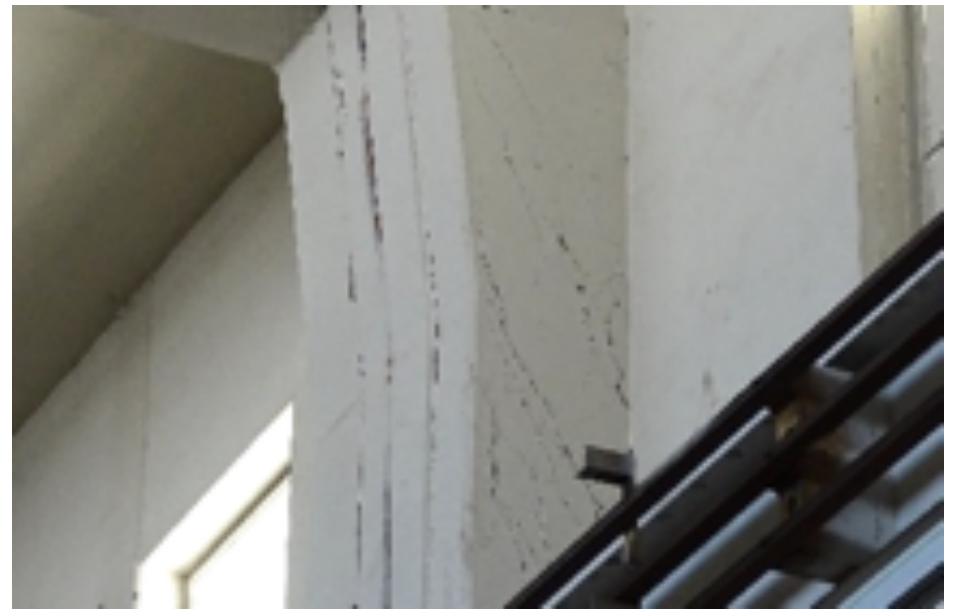
Concrete Frame and Shear Wall Building
