NAWS China Lake Earthquake Response and Recovery

SAME San Diego Post Luncheon
September 11, 2019

ReidMiddleton

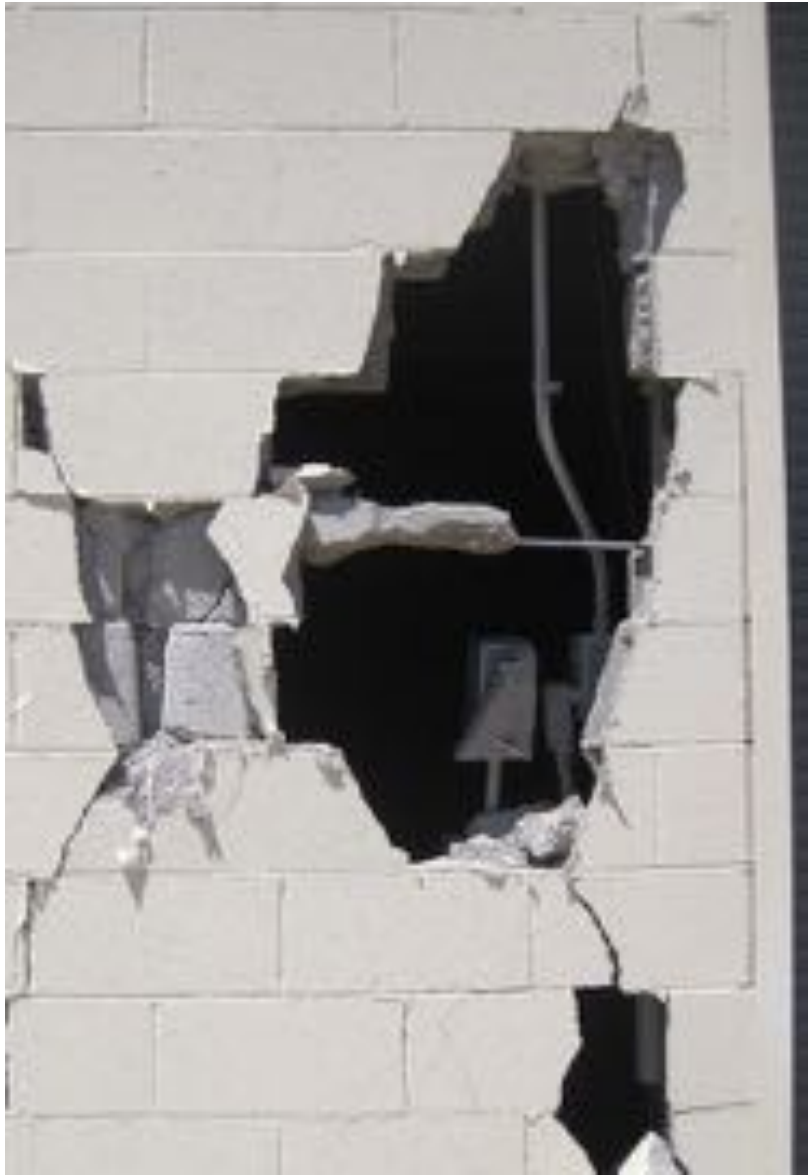
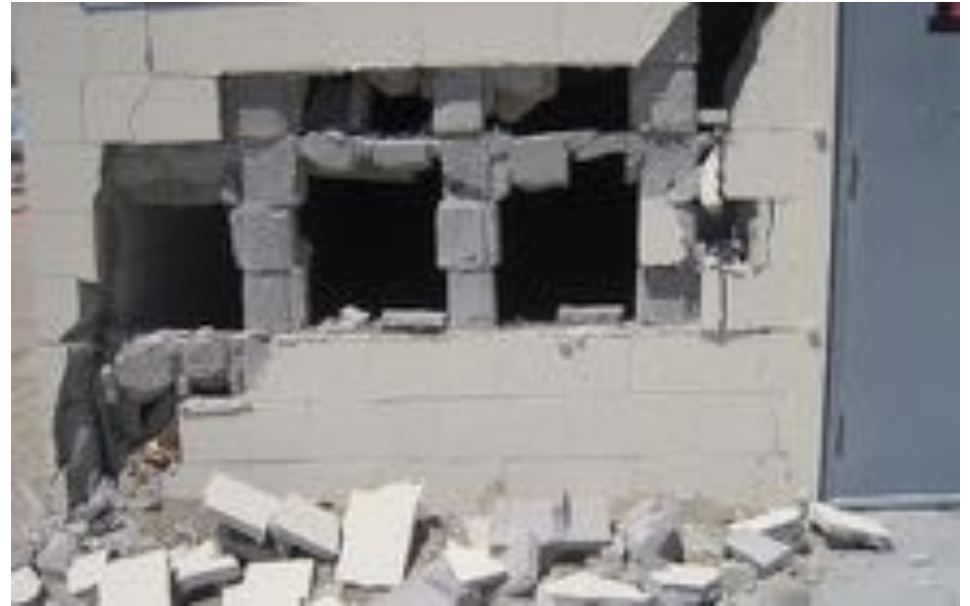
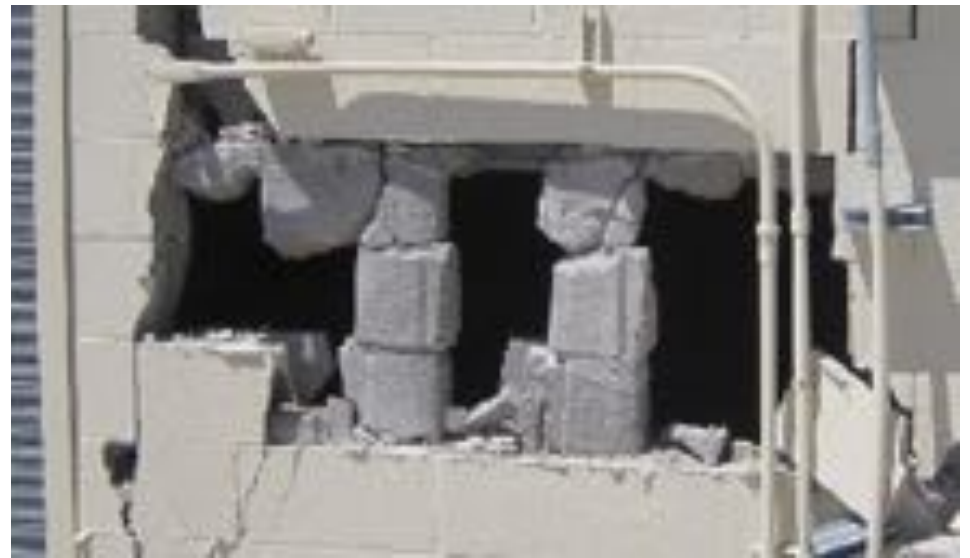
Masonry Building

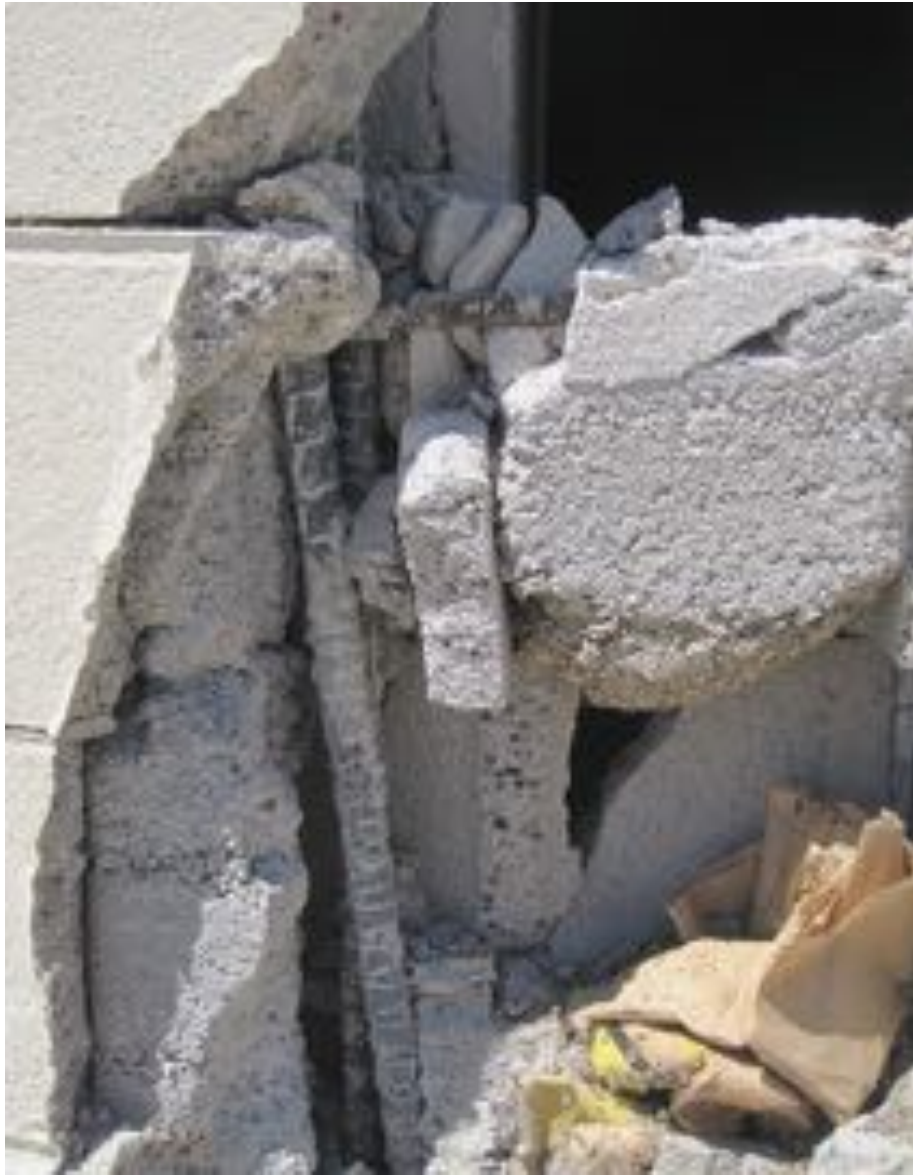
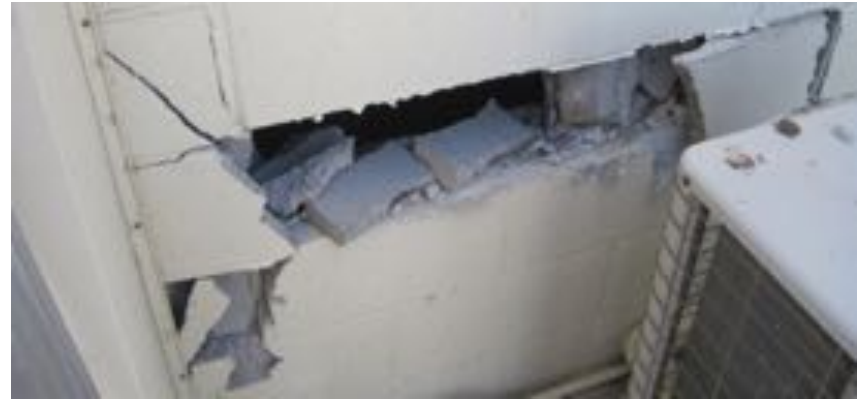
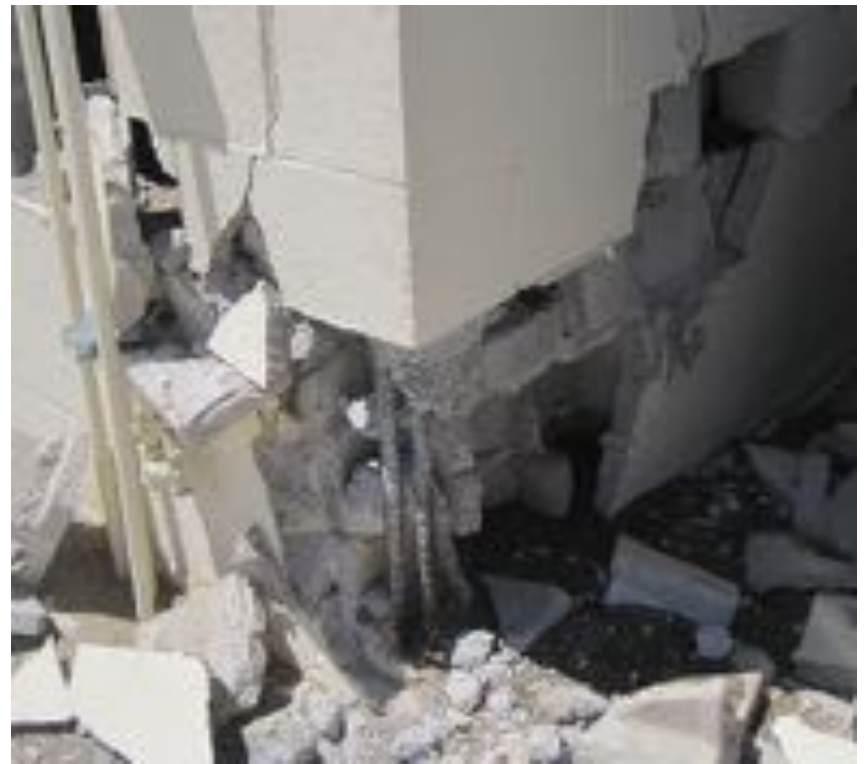
Masonry Building
